**REVISED FIELD ADVISORY**  
**Supersedes RegO Field Advisory Issued on February 3, 2017**

**L7579 1-3/4" X 1-1/4" MNPT Filler Valve**  
**Date Codes 8B16 to 1C17**

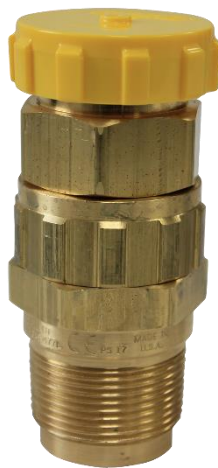
**L7579 with 3179B  
adapter installed.**

1. We advise that you use a 3179 Filler Valve Adapter whenever you fill through an affected L7579 fill valve with date codes of 8B16 to 1C17, which is consistent with best industry practices for safety during every fill operation. If for some reason you did not use a 3179B fill adapter and have an issue disconnecting from any fill operation, please exercise extreme caution and follow your company procedures to prevent an accident.

It is a best practice to use filler hose adapters like the 3179B when conducting any filling operation into a 1-3/4" ACME filler valve. When a filler hose adapter is attached to the hose end valve connection during the filling process and there is a problem disconnecting due to leakage through the upper check, the 3179B or other type filler hose adapters can remain on the subject filler valve. This will allow the delivery person to safely disconnect the hose end valve from the filler hose adapter which will remain connected to the subject filler valve leak free.
